Manhole Inspection Summary

Manhole # S11EE2005MH

Location Address: **2217 CROSS COUNTRY BLVD**

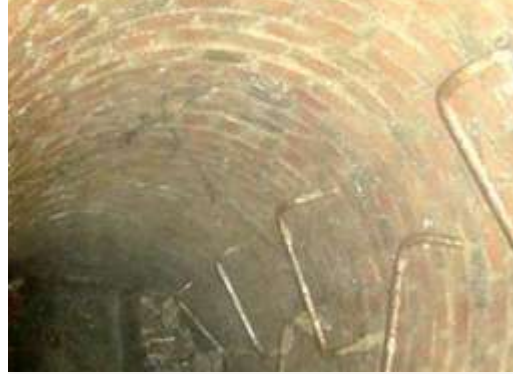
Top View

Adjustment and Corbel infiltration. Barrel root intrusion and infiltration.

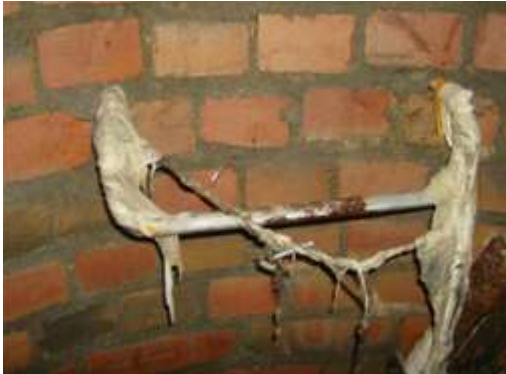
☒ **Evidence Of Surcharge** Depth: **5** (ft.) ☐ Active Surcharge Present

Evidence of surcharge

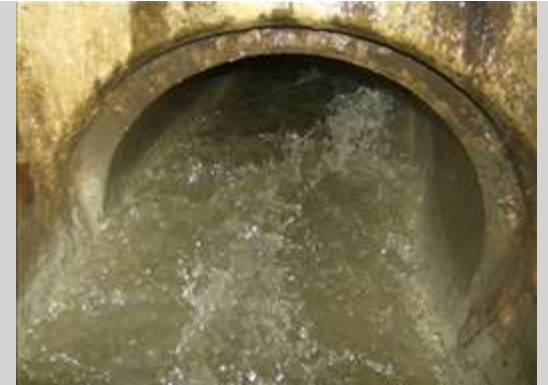
24 in. Circular Gravity Sewer Pipe Out @ 12 O'Clock

Pipe Material: **Clay** ☐ Pipe Lined

Invert Depth: **21.25** (ft.) Flow Characteristics: **Fast**

Infiltration: **None** Pipe Seal Cond: **Sound**

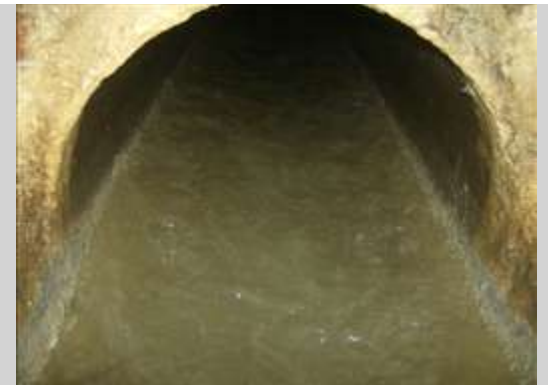
24 in. Circular Gravity Sewer Pipe In @ 6 O'Clock

Pipe Material: **Clay** ☐ Pipe Lined

Invert Depth: **21.21** (ft.) Flow Characteristics: **Fast**

Infiltration: **None** Pipe Seal Cond: **Sound**

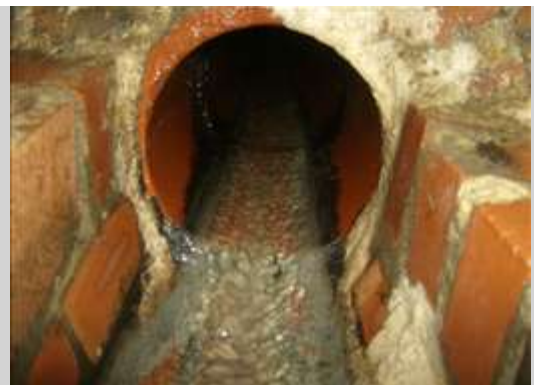
12 in. Circular Gravity Sewer

Pipe Material: **Clay**

Invert Depth: **19.80** (ft.) Flow Characteristics: **Fast**

Infiltration: **None**

Pipe Seal Cond: **Sound**
